SEM/TEM FRACTOGRAPHY OF COMPOSITE MATERIALS

General Dynamics  
Fort Worth Division  
P.O. Box 748  
Fort Worth, Texas 76101

SEPTEMBER 1982

FINAL REPORT FOR PERIOD: October 1979 - March 1982

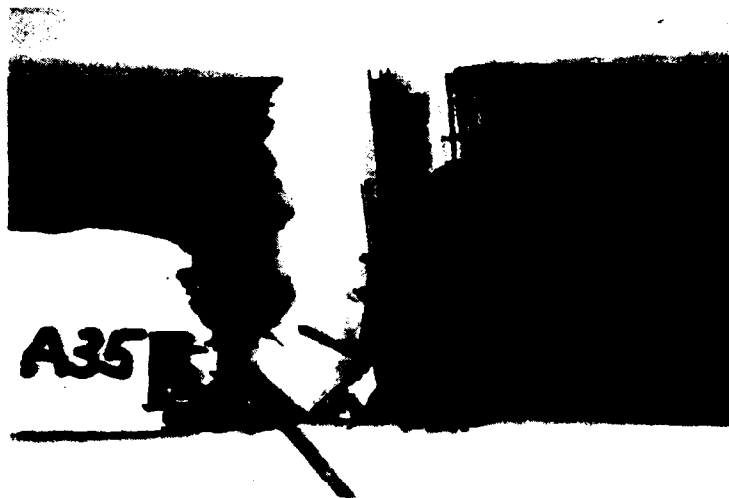
Figure 4 Macroscopic Fractographs of Typical  $[0/\pm 45/90]_{2S}$  Failure Surface , 2X

The ultimate failure of a composite laminate is a high energy event. The magnitude of energy released is directly proportional to the number of 0° lamina present. The combination of this high energy release and the large amount of pre-failure damage produces a highly fragmented failure surface (Fig. 4) making comprehensive fractography quite difficult.

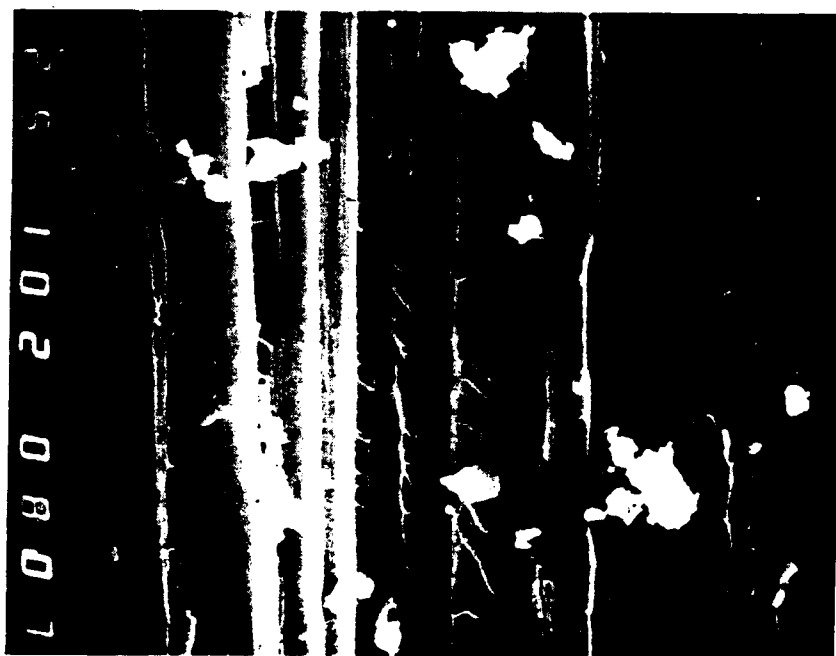
Figure 15 River Pattern in Resin Material Between Fibers in Mode I Specimen , 1000X

River patterns are evident at magnifications of 500X or higher in the resin material between fibers and in resin-rich regions (i.e., resin pockets which form when plies are butted together or at flaws in prepreg tape). The proposed explanation for their formation is that separate cleavage crack segments develop on parallel planes within the matrix regions. As the segments run through the resin, they grow in width and approach each other. Eventually, the crack segments join together fracturing thin ligaments of material and forming steps between the parallel cleavage planes. These steps converge in the direction of local crack propagation. Figures 14 and 15 illustrate typical river patterns found on Mode I type specimens. The pattern in Fig. 14 developed at a resin-rich region within the lamina while the pattern in Fig. 15 illustrates the cleavage of matrix material between fibers.

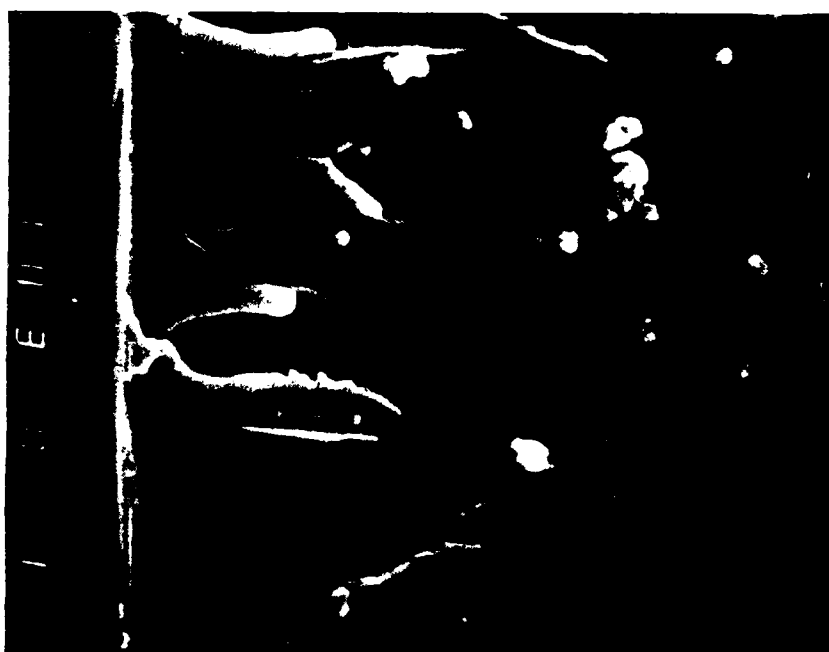
Figure 16 Photomicrograph of Feather Pattern on Mode I Specimen , 10,000X

Another distinct cleavage-fracture feature, the feather pattern or feather mark, was also evident in the failed matrix material. Compared to river patterns, feather marks are more difficult to detect; they have a finer texture and are seen at 3000X or more. They are chevron shaped surface marks which point back in the direction of local crack origin. Figure 16 is a 10000X photomicrograph of the surface of a Mode I specimen in which both river patterns and feather patterns are evident. Complex feather patterns were also found on Mode II specimens. Figure 17 is an example of such a pattern.

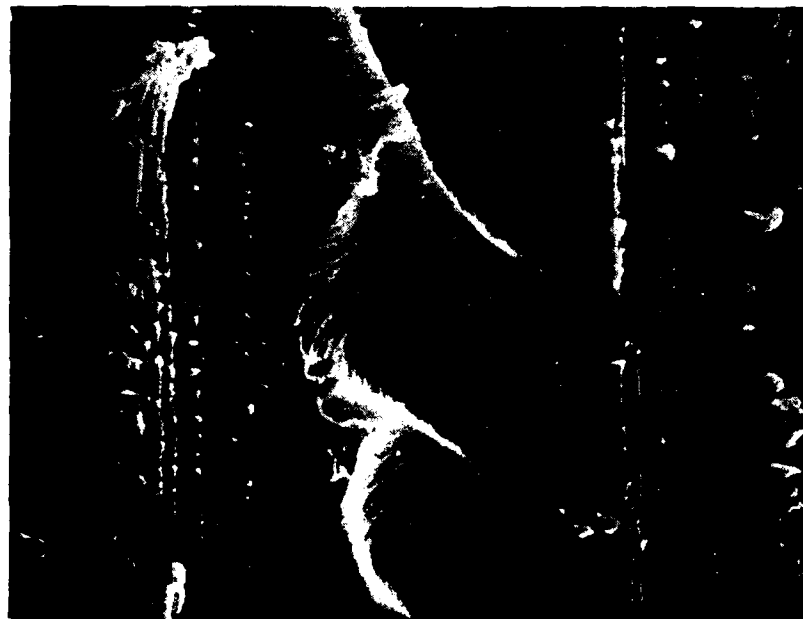
Figure 17 Photomicrograph of Feather Pattern on Mode II Specimen , 5000X

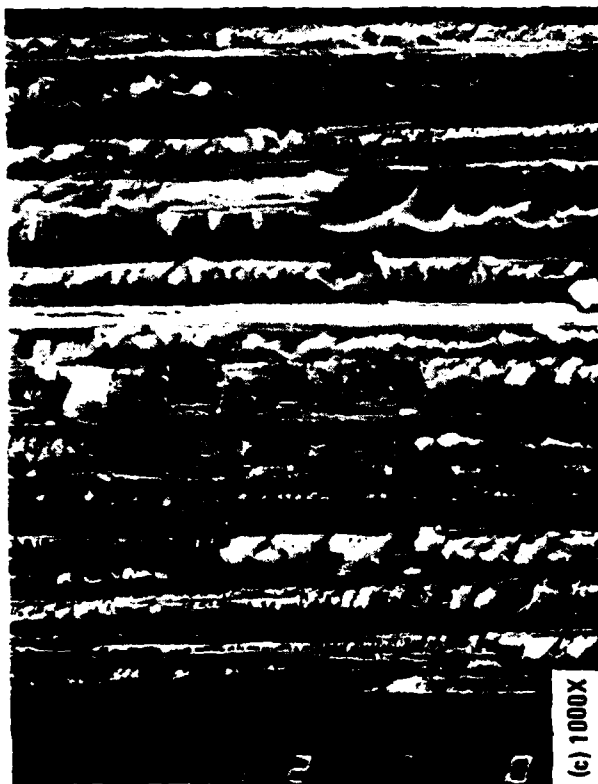
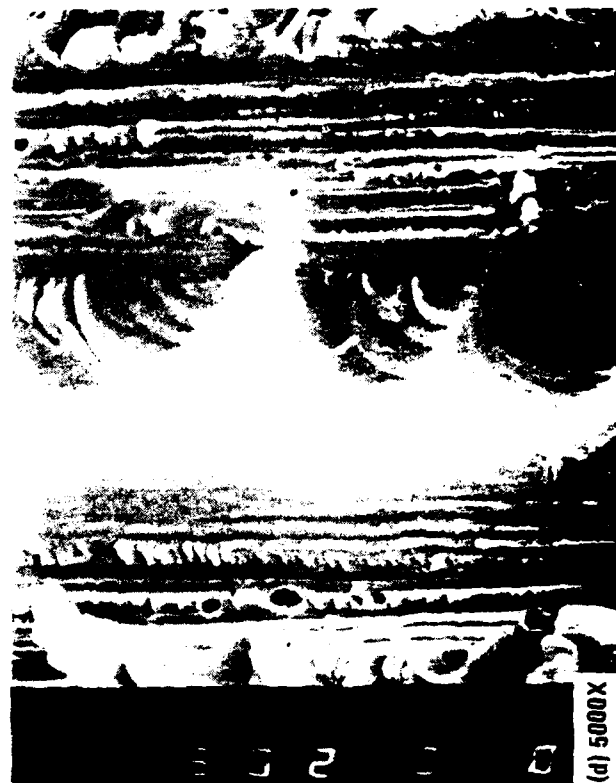
Figure	Characteristic
a	Planar Fracture Surface (macroscopic)
b, c	Hackles of Varied Inclination
c, d	Feathered Scallops

Figures 19b, c, and d Photomicrographs of G12 Shear Specimen Surface

Figure 19b, c, d are SEM photomicrographs of the fracture surface. Relatively few fiber breaks were observed over the specimen. The key surface features were hackle patterns in the epoxy resin between the fibers. These raised patterns showed consistent orientation over each fracture surface. Although the angle of inclination varied in regions, the general tilt direction was constant.

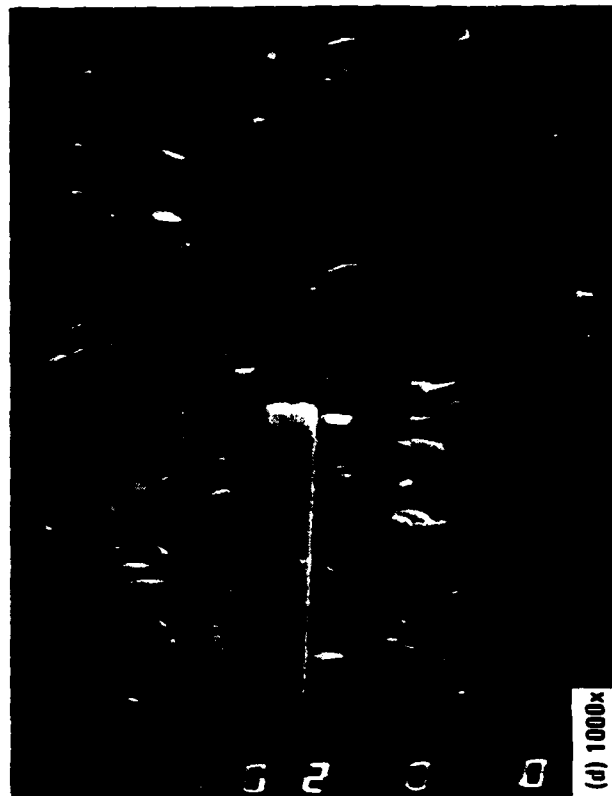
Figure	Characteristic
a	Planar Fracture Surface (macroscopic)
b,c,d,e	Hackle Pattern of Varied Inclinations

Figure 20b, c, and d Photomicrographs of the Same Region of a G31 Fracture Surface

Figure 20 shows a typical region of a  $G_{31}$  shear specimen surface. It contains three photographs (b, c, and d) of the same area taken at 200X, 500X and 1000X. The raised epoxy platelets are particularly evident at higher magnifications. Regions of the matrix material also displayed curved surfaces where it appeared the material had been "scooped" away. Feather patterns are evident on the surfaces of these scooped or "scalloped" regions at higher magnifications. Note the similarity between the  $G_{12}$  and the  $G_{31}$  surfaces shown in Figs. 19 and 20, respectively.

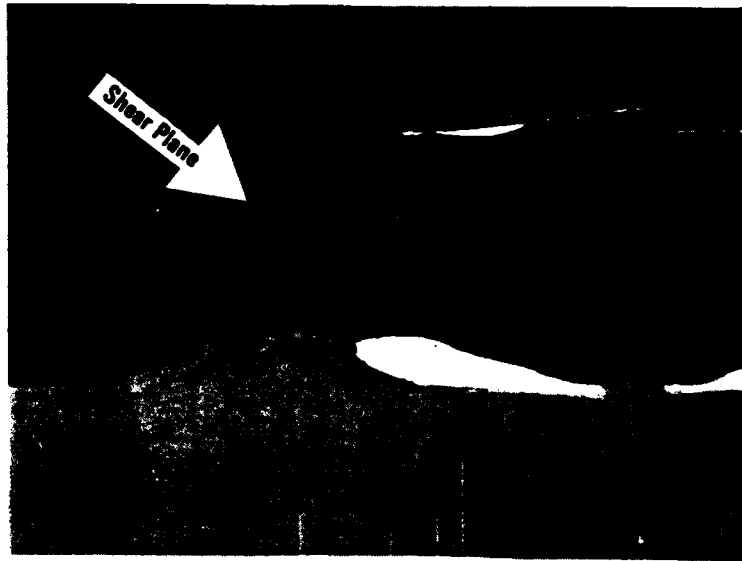
Figure 30a "X" Mode of Failure in 90° Specimens Under Compression , 5X

On a macroscopic scale, the  $90^\circ$  compression specimens fail due to the formation of two major fracture planes which intersect in the form of an "X". These planes occur approximately along the line of maximum shearing stresses ( $\pm 45^\circ$ ). Figure 30a is a photograph of the edge of a specimen and shows that, on the right half of the specimen, an apex is formed by the intersecting planes. A view of the apex feature in the same specimen is shown in Figure 30b which also indicates that a small number of plies at the surface form a planar shelf which is roughly perpendicular to the direction of loading. A 50X magnification of the apex area shown in Figure 30b is shown in Figure 30c. The face to the left side of the specimen (left) has a noticeable lack of debris when compared to the face on the

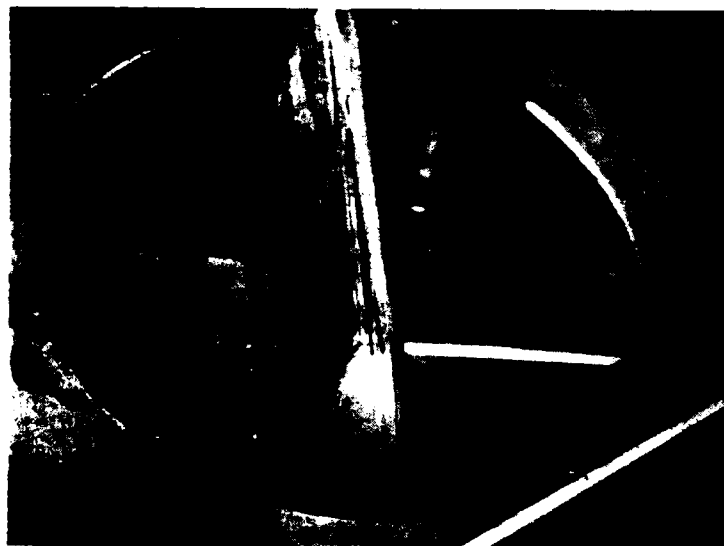
Figure 30b Apex Feature in 90° Specimens Under Compression , 2X

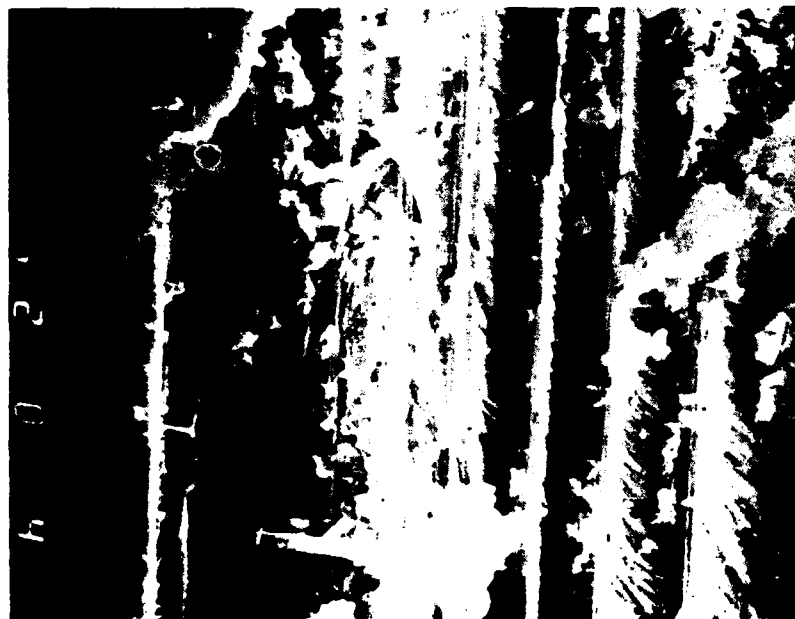
Figure 30d Debris Formed by Abrasion on Compressive Face of Apex Feature , 1500X

compressive side. Figure 30d shows a photomicrograph of the granulation believed to have been formed by abrasion between the surfaces. Consequently, the features of the fracture surface were obliterated by secondary damage formations. Consequently, emphasis was placed upon the right side where the features remained free of debris. In Figure 30e (5000X), the apex is to the right and the tensile face is to the left. The cleavage planes are relatively smooth and the river markings imply that the crack direction was from left to right (i.e., originated at the edge and propagated toward the apex). Evidence of shear failure is also evident on this surface. Figures 30f,g are an example of the hackle patterns typical of shear failure. Also in Figure 30g a crack extending into the surface is evident. In summation, this failure surface is mixed mode, evidence of both Mode I and II are found. Figure 30h is an example of a transition region between Mode I left and Mode II right.
